September 1945 as
Memorandum Report E5I27a

**EFFECT OF MAXIMUM CRUISE-POWER OPERATION AT ULTRA-LEAN
MIXTURE AND INCREASED SPARK ADVANCE ON THE MECHANICAL
CONDITION OF CYLINDER COMPONENTS**

By Herbert B. Harris, Robert T. Duffy, and Robert D. Erwin, Jr.

Aircraft Engine Research Laboratory
Cleveland, Ohio

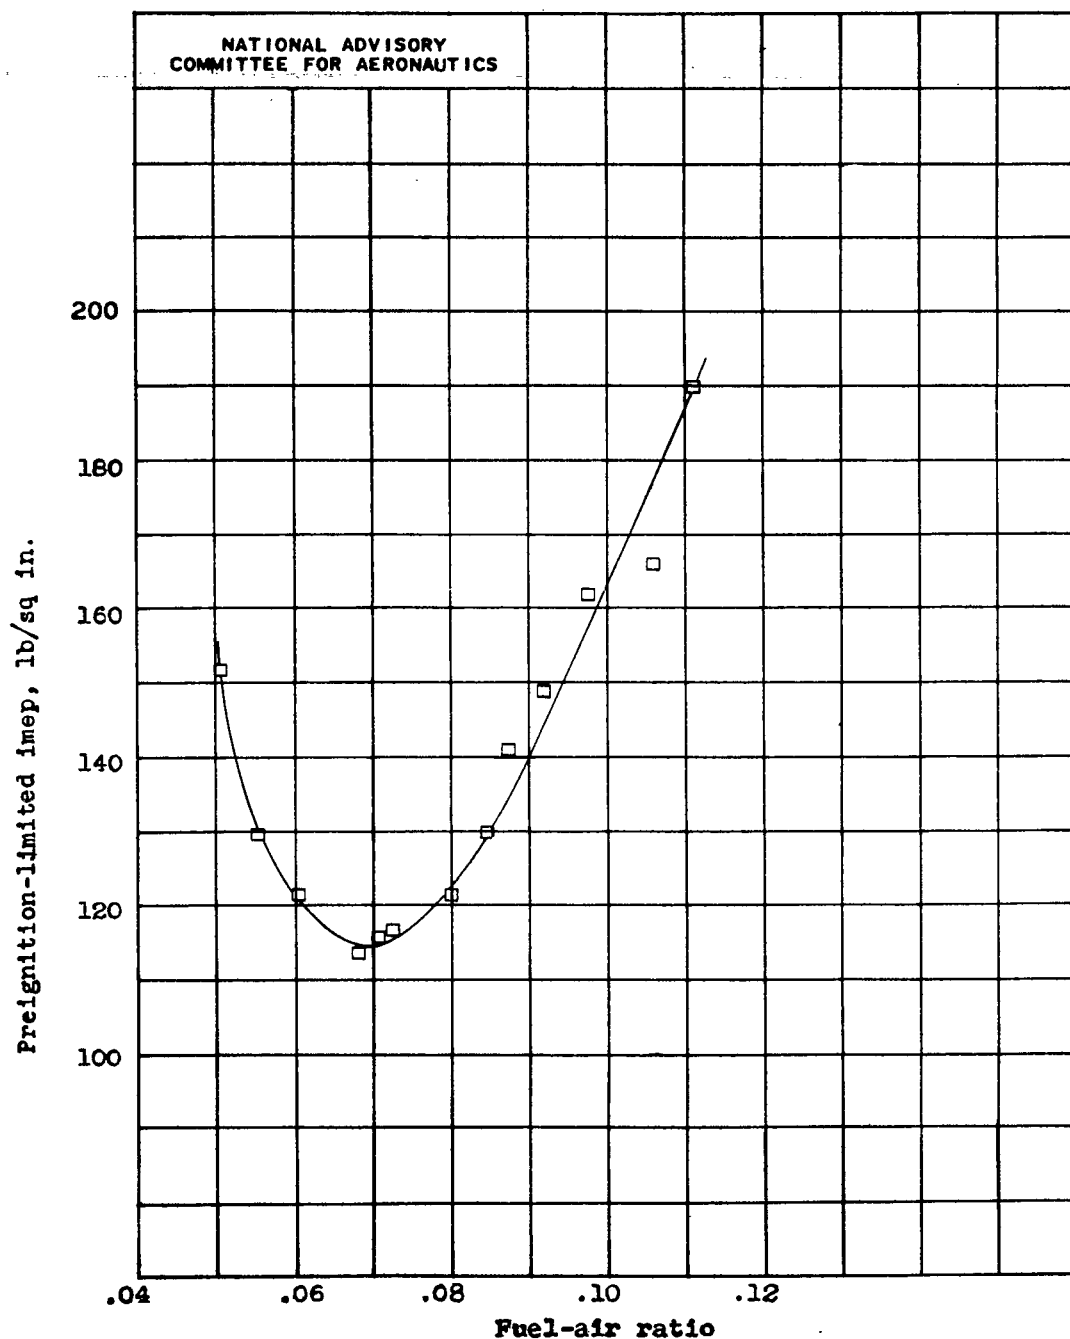
Figure 14. - Preignition-limited performance of 28-R fuel. CFR engine; open tube hot spot; engine speed, 1800 rpm; inlet-air temperature, 225° F; coolant temperature, 250° F; spark advance, 20° B.T.C.; compression ratio, 7.0. (Data from reference 15.)

Preignition. - Although preignition may be the result of engine knock, it may lead to engine failure without any indication of knock (reference 15). Figure 14 has been included to indicate the effect on the preignition-limited power output of engine operation at the conditions of this test as compared with operation at the conditions recommended by the Army for the same power. The data for this preignition-limit curve were obtained from a single-cylinder CFR test engine at an engine speed of 1800 rpm, at a spark advance of 20° B.T.C., and at a compression ratio of 7.0 (reference 15). Because the engine and operating conditions for this curve are different from those of the test reported herein, a comparison of absolute values is not possible. The relative values, however, should be indicative of the effect of fuel-air ratio on the preignition limit of the engine used in this test.

The preignition-limited power for a fuel-air ratio of 0.052 is 21 percent higher than that for a fuel-air ratio of 0.076 for the same spark advance and engine speed (fig. 14). A correction of the preignition-limited power at a fuel-air ratio of 0.052 for the increase in spark advance from 20° to 30° B.T.C. made according to the data of reference 16 showed that it should be decreased approximately 20 percent. The effect of the 100 rpm difference in speed between the two conditions should be of comparatively small magnitude as indicated by the data of this reference. The net effect on the preignition-limited power output of engine operation at the conditions of this test as compared with operation at the conditions recommended by the Army for the same power should therefore be negligible.
